# Douglas County Schools

Douglas County School District  
620 Wilcox Street  
Castle Rock, CO 80104

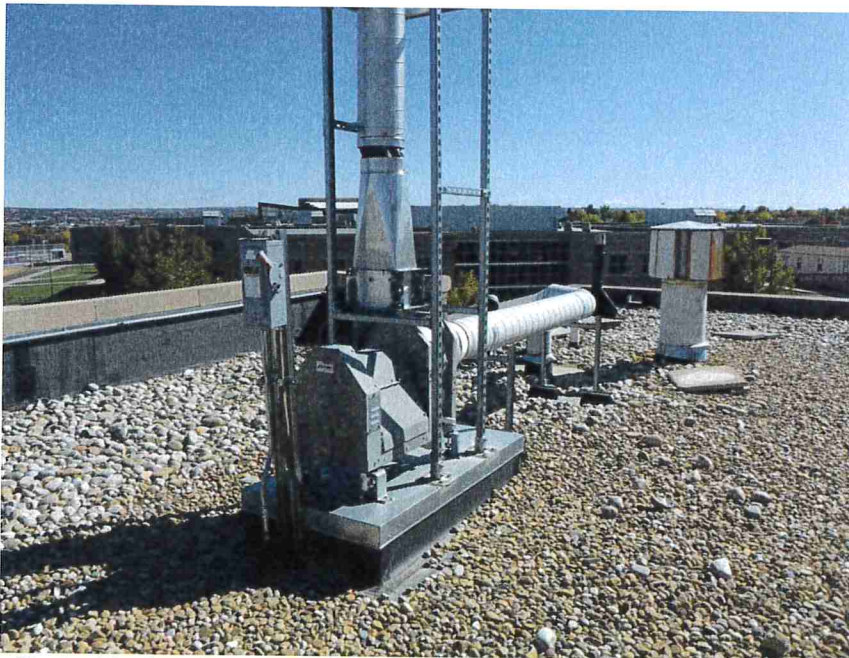
Photo 12 – Roof equipment was mounted on curbs, similar to the exhaust fan depicted. There were no observed holes or tears in the membrane at the curbs.

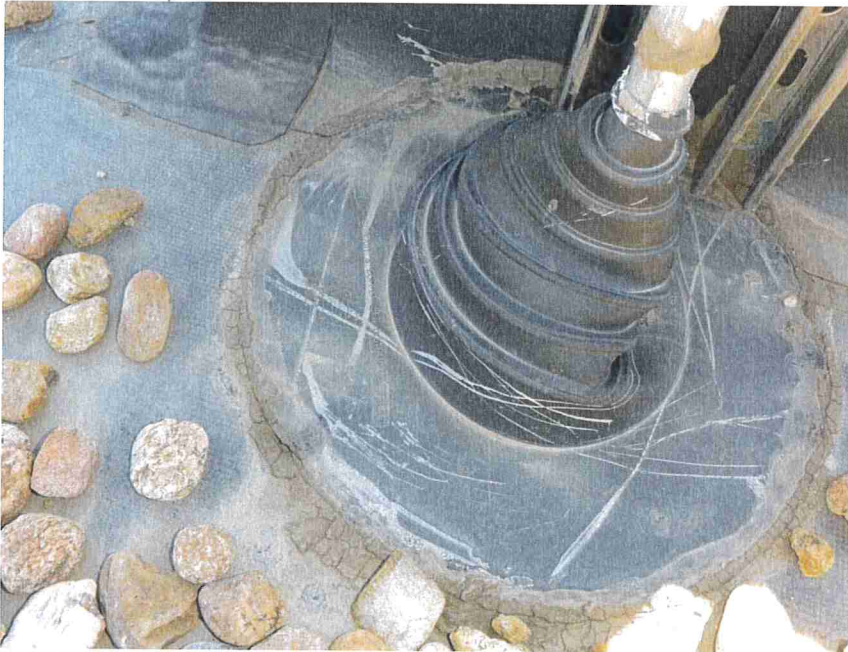
Photo 13 – Sealant around the membrane flashing was cracked and brittle, although was still bonded to the membrane.

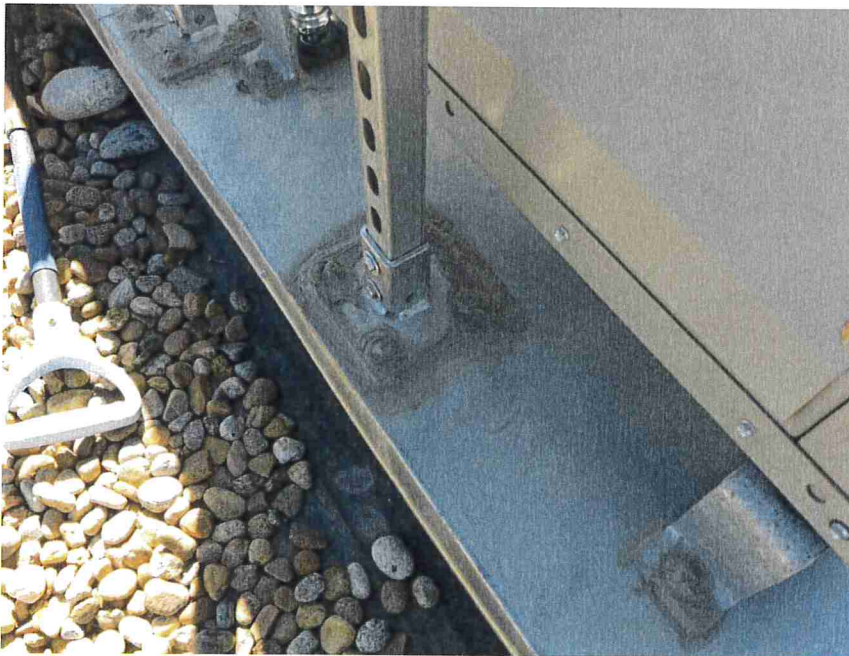
Photo 14 – Sealant was placed around fasteners at the exhaust fan. No holes were observed in the sealant.

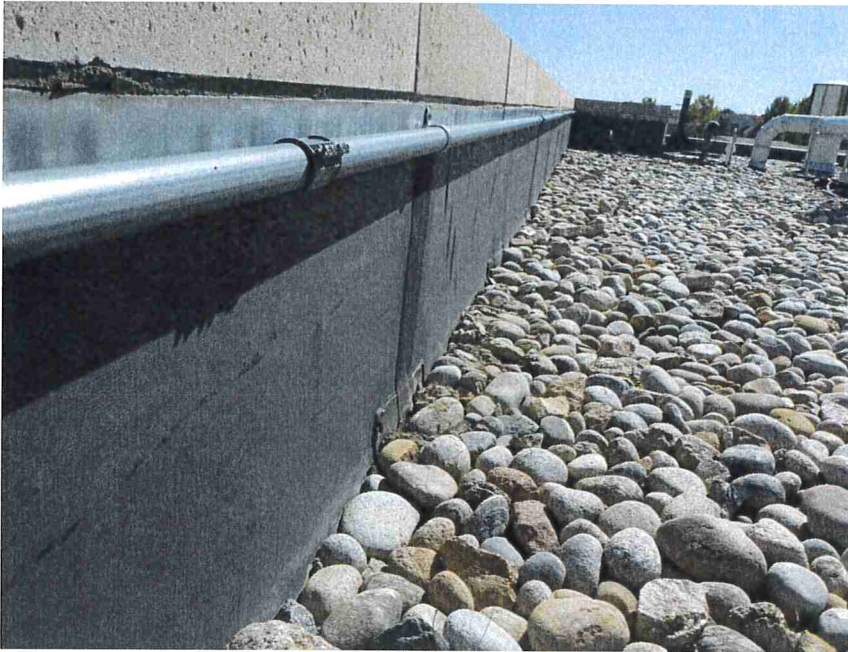
Photo 15 – Along the parapet walls, the membrane was not “tented” or pulled away from the parapet wall.

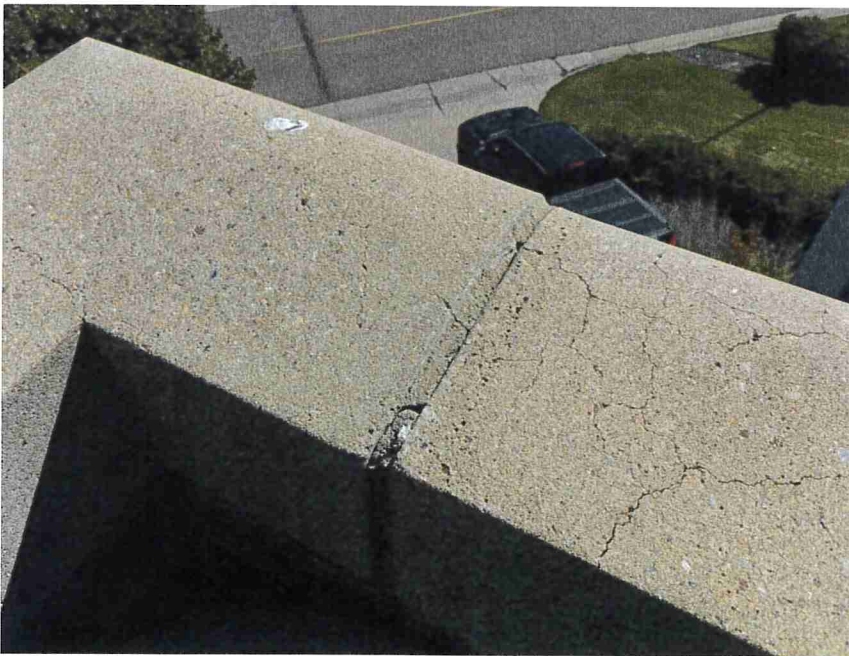
Photo 16 – Precast coping and mortar joints at the top of the parapet had cracks.

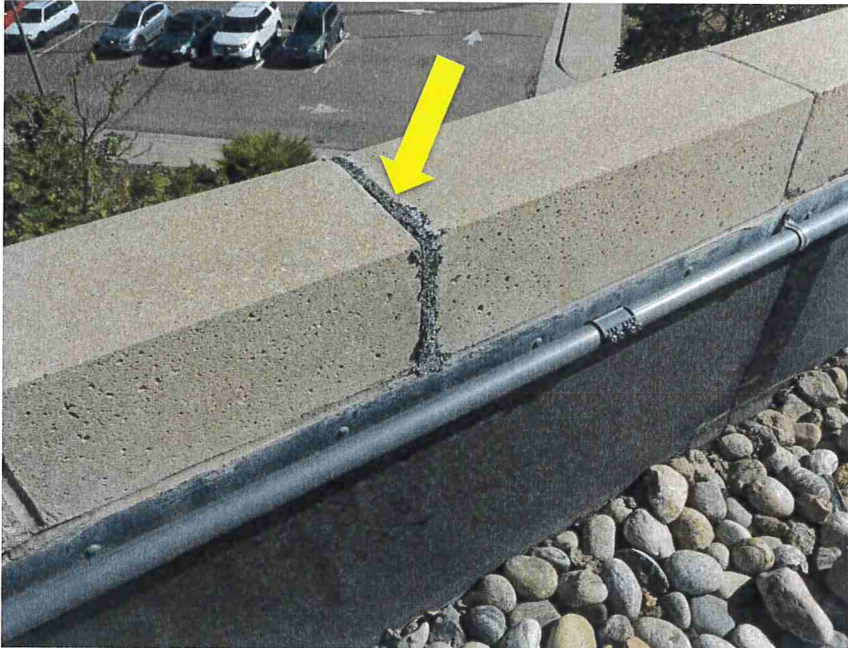
Photo 17 – Mortar at the joint between sections of precast coping appeared different from adjacent areas.

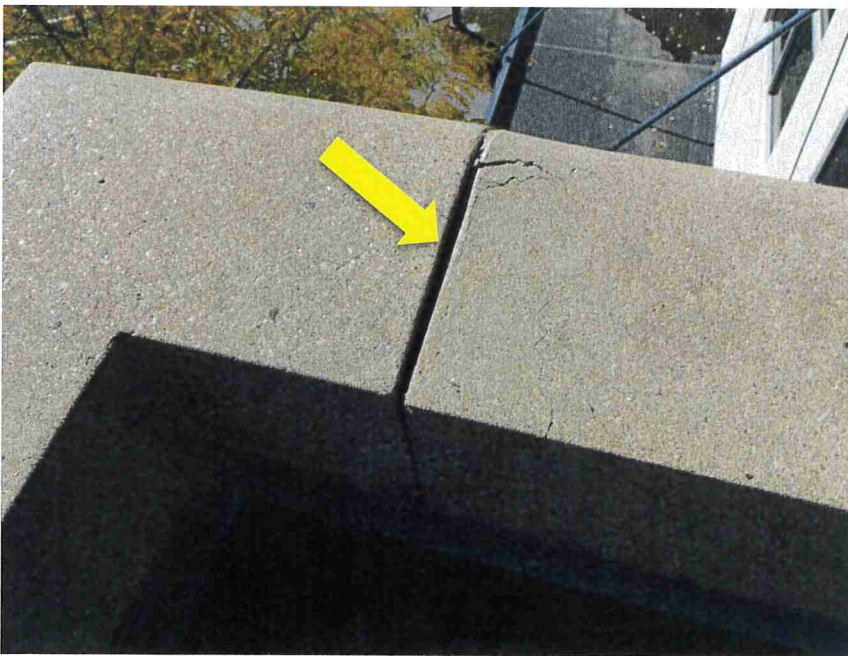
Photo 18 – At the southwest corner of the main roof, the mortar was missing in the joint of the precast coping.

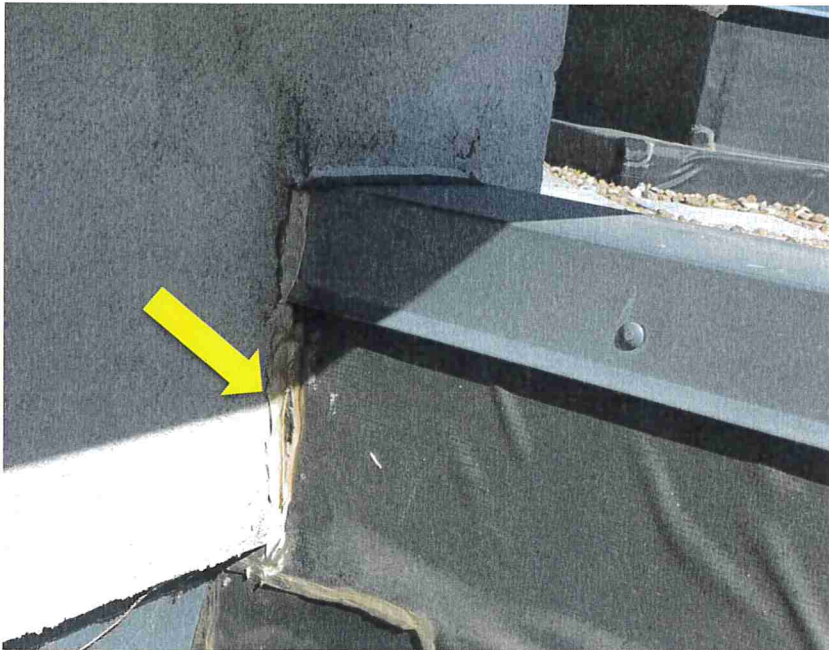
Photo 19 – Multiple layers of sealant were visible at the EPDM to EIFS transition at the southwest section of the ballasted EPDM roof.

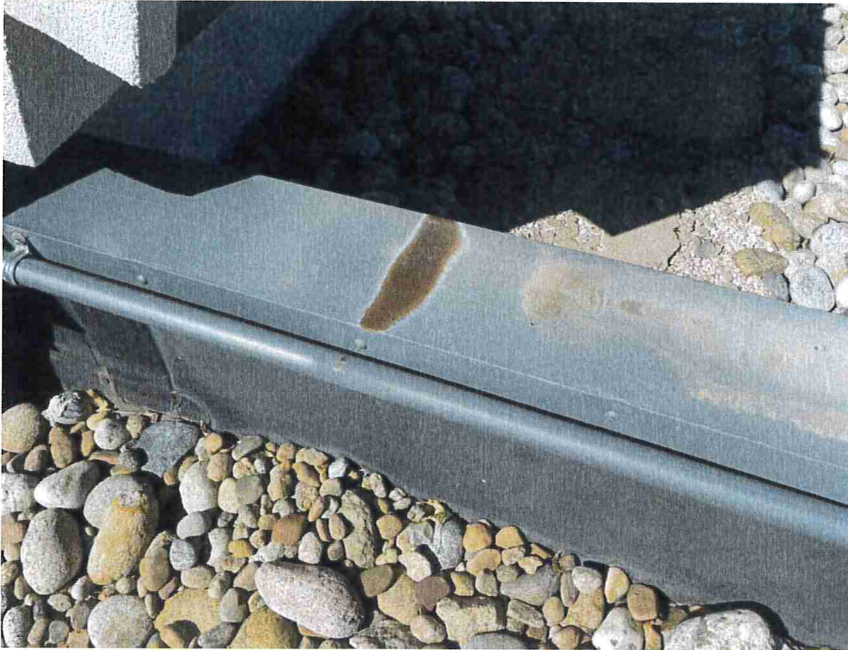
Photo 25 – Coping was corroded at the parapet wall between the main and northeast ballasted EPDM areas.

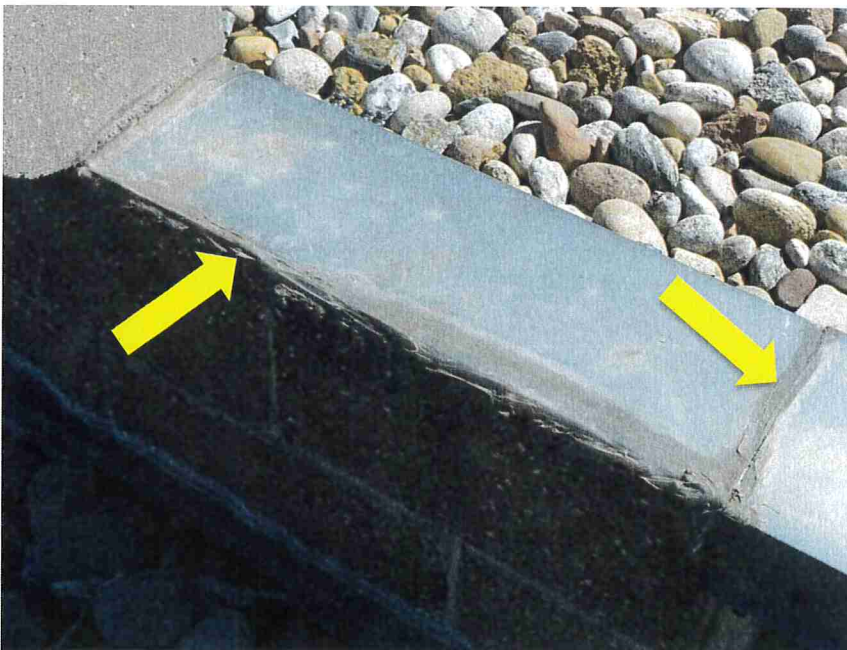
Photo 26 – The metal coping did not extend fully over the parapet wall. Sealant was placed at the joints in the coping and along the transition to the masonry parapet wall.

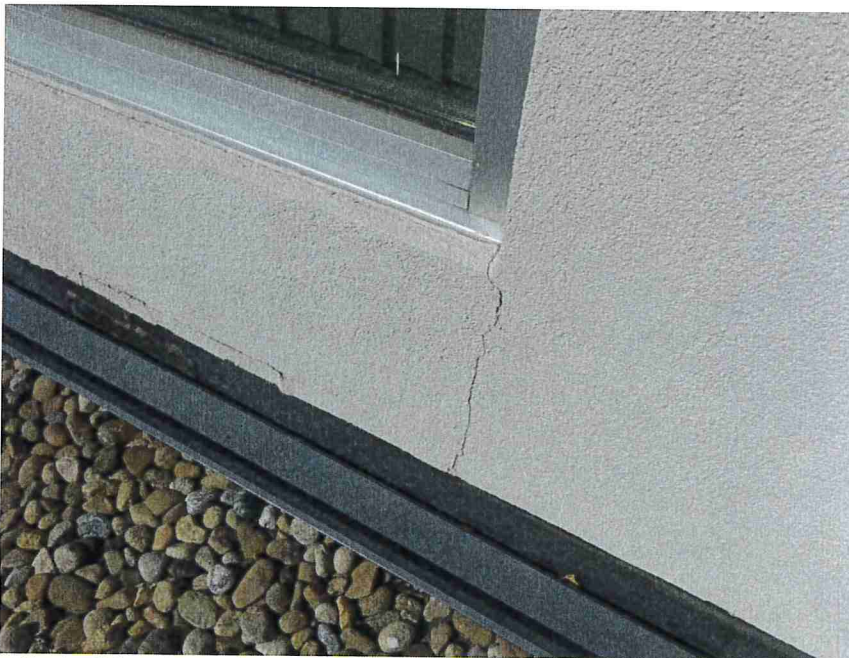
Photo 36 – A crack was located at the bottom corner of the window opening in the EIFS on the north wall.

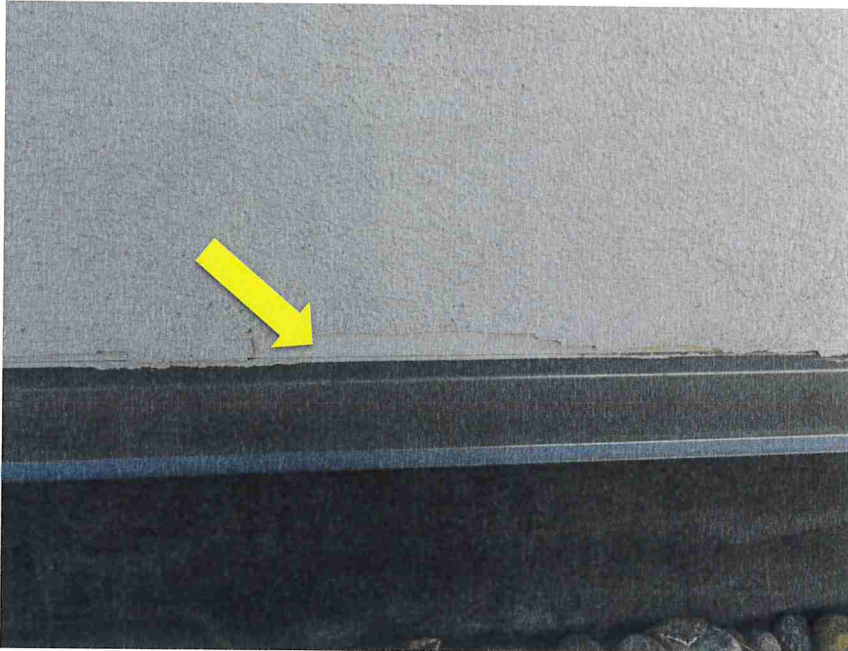
Photo 37 – Additional localized areas of missing finish coat at the EIFS were observed above the roof.

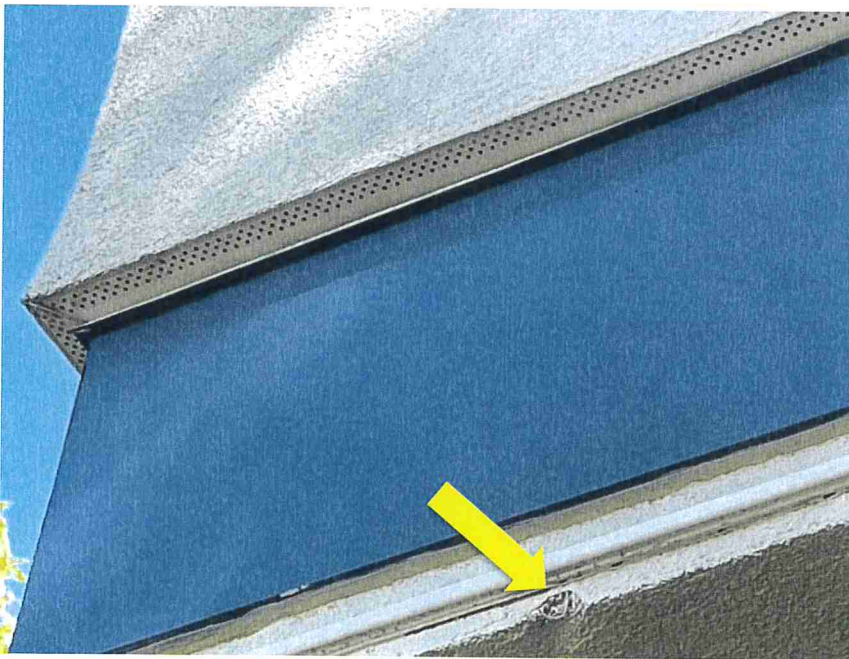
Photo 38 – Weeps were visible below the EIFS on the building exterior. Localized damage to the finish was observed (indicated).

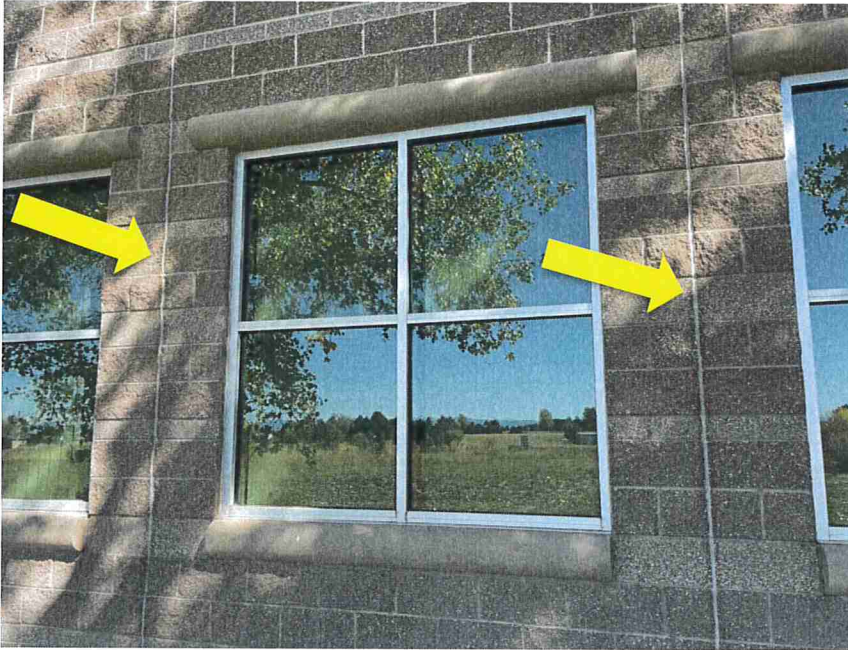
Photo 39 – Control joints were placed in the exterior split-face concrete masonry units (CMU).

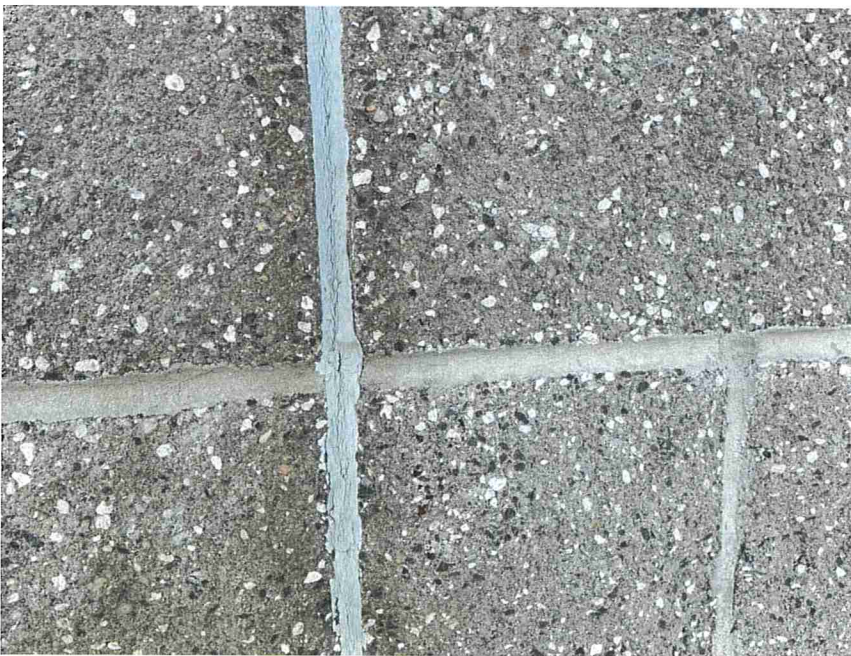
Photo 40 – Sealant in the control joints was becoming brittle and starting to exhibit cracks.

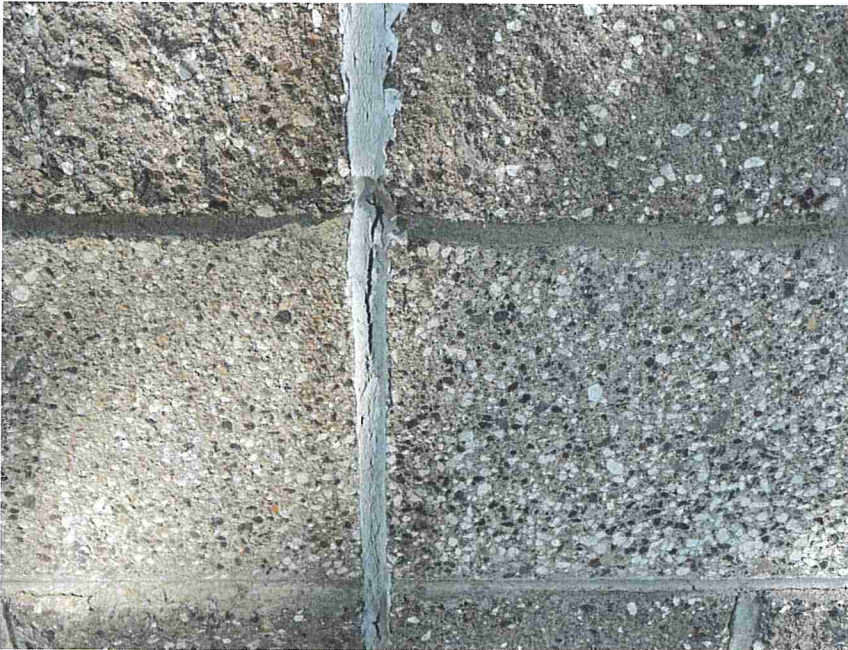
Photo 41 – Sealant at some control joints had holes and gaps, allowing water and moisture to enter the wall assembly.

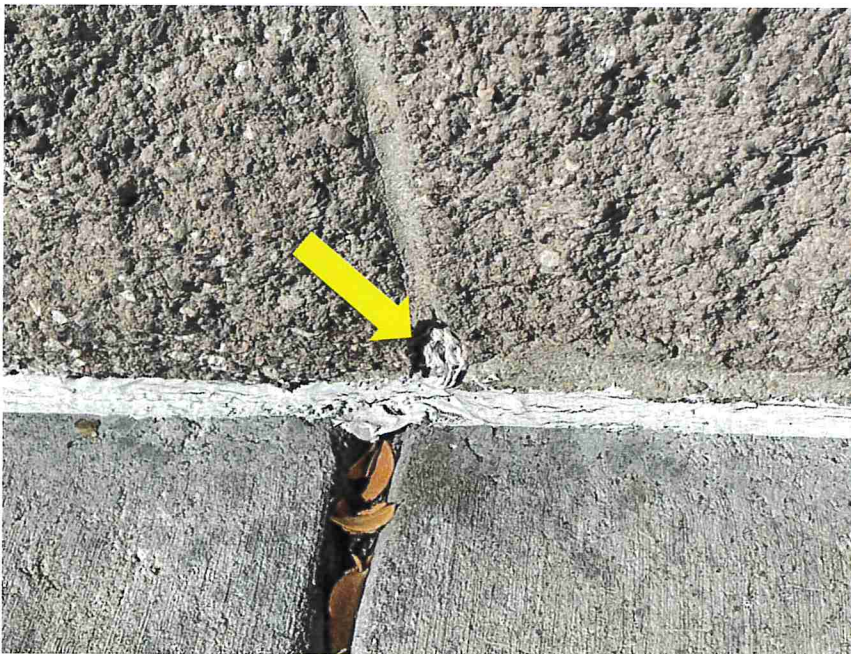
Photo 42 – Weeps were visible along the exterior at grade.

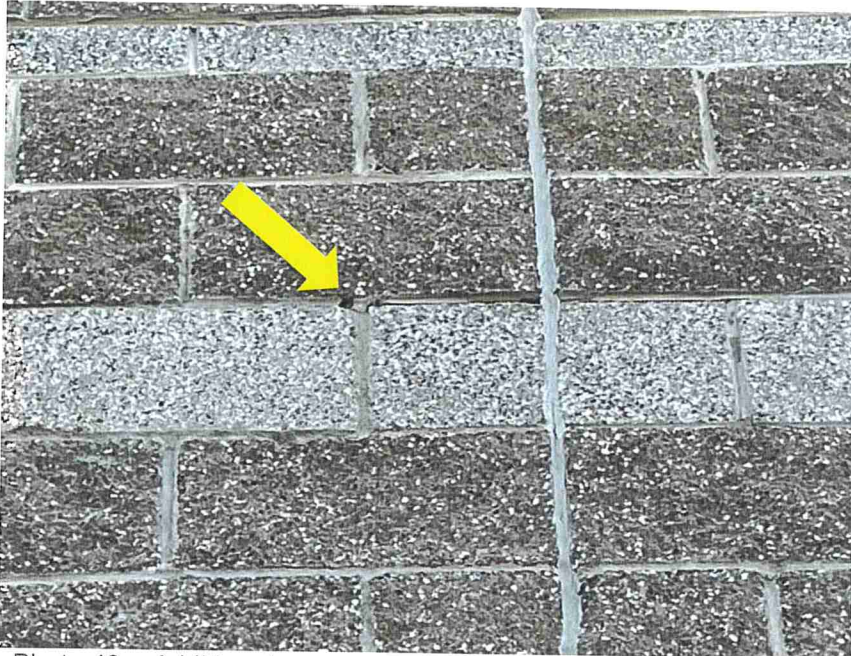
Photo 43 – Additional weep holes were observed around the building exterior.

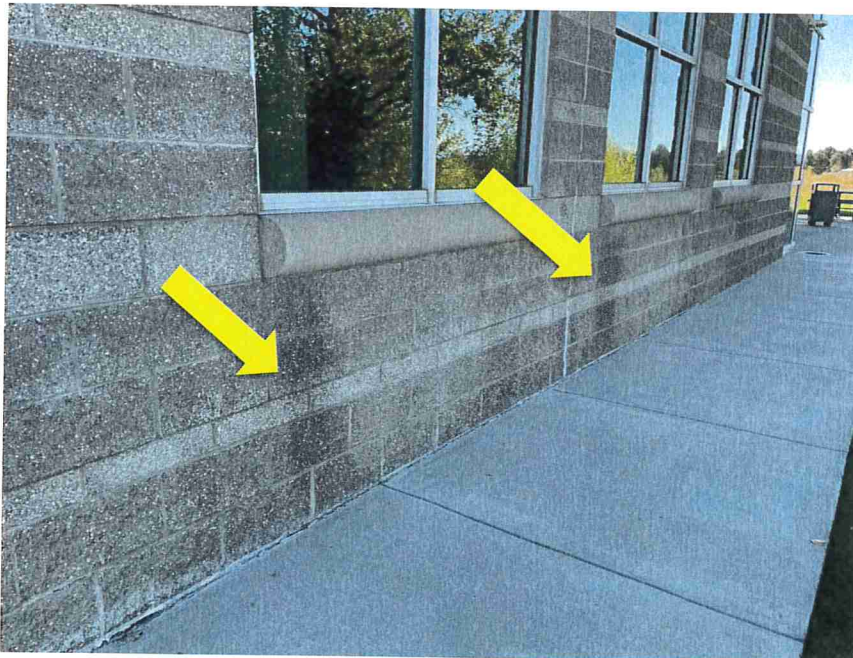
Photo 44 – Discoloration was located below the windows on the first level.

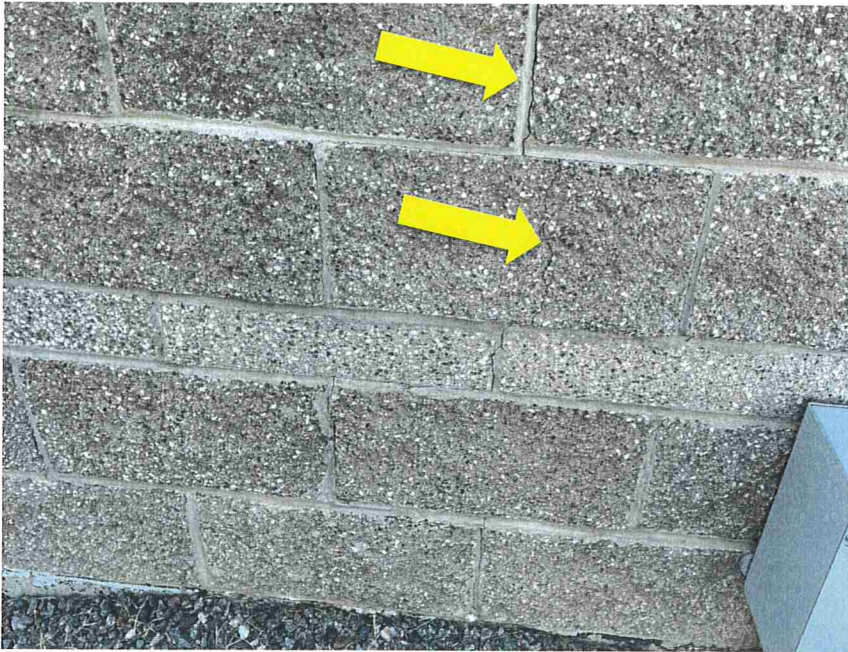
Photo 45 – Cracks in the exterior were observed at the southeast corner (indicated). The cracks were in the mortar joint and across the split-face CMU.

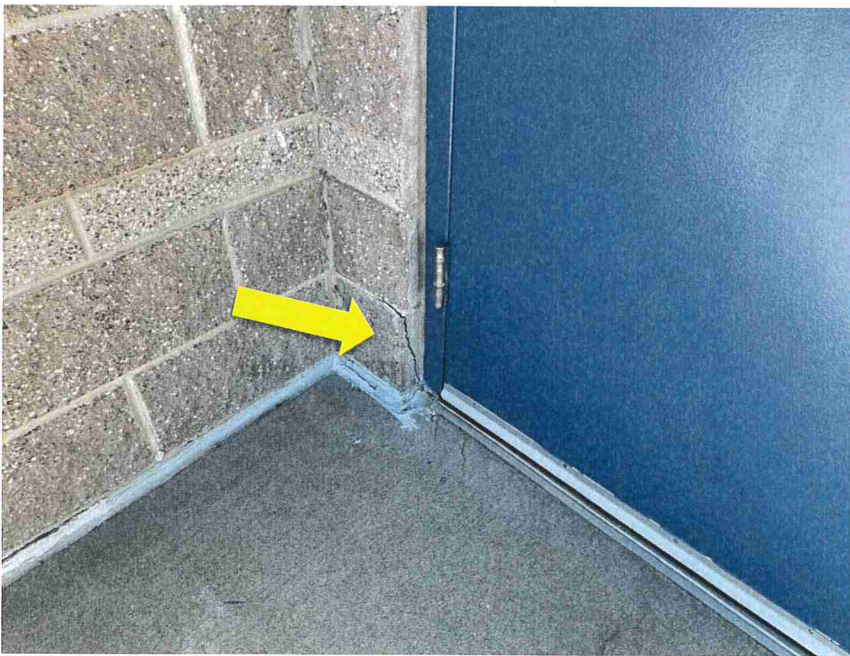
Photo 46 – At the southeast corner of the building, the face of the CMU was cracked at the door jamb.

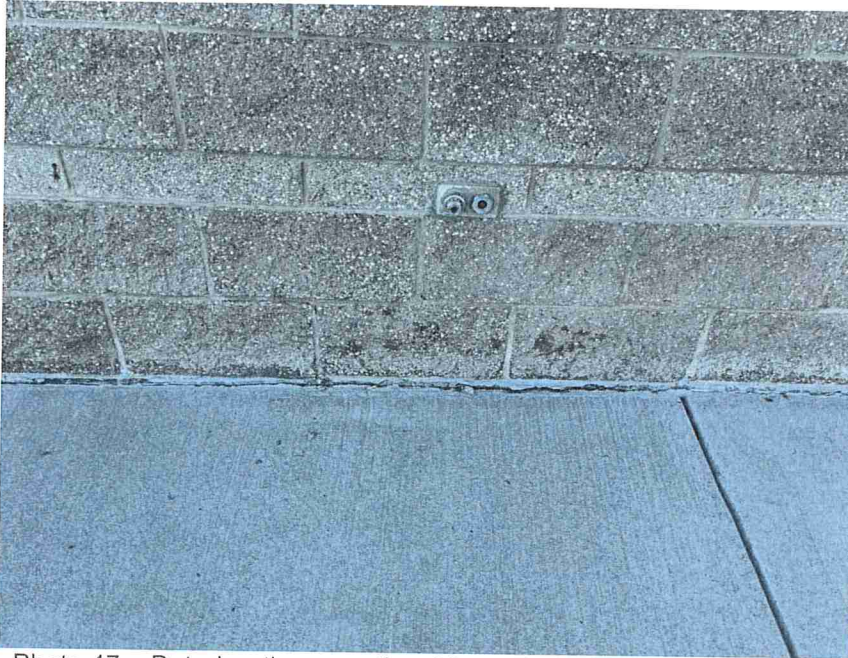
Photo 47 – Deterioration near the sidewalk was observed on the exterior face of the split-face CMU.

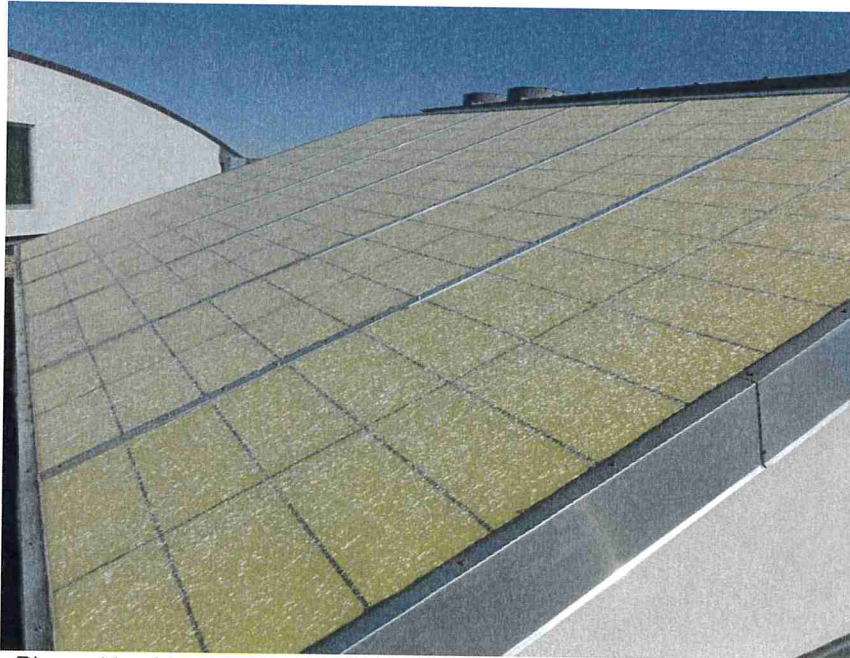
Photo 48 – View showing the skylight in the main roof area.

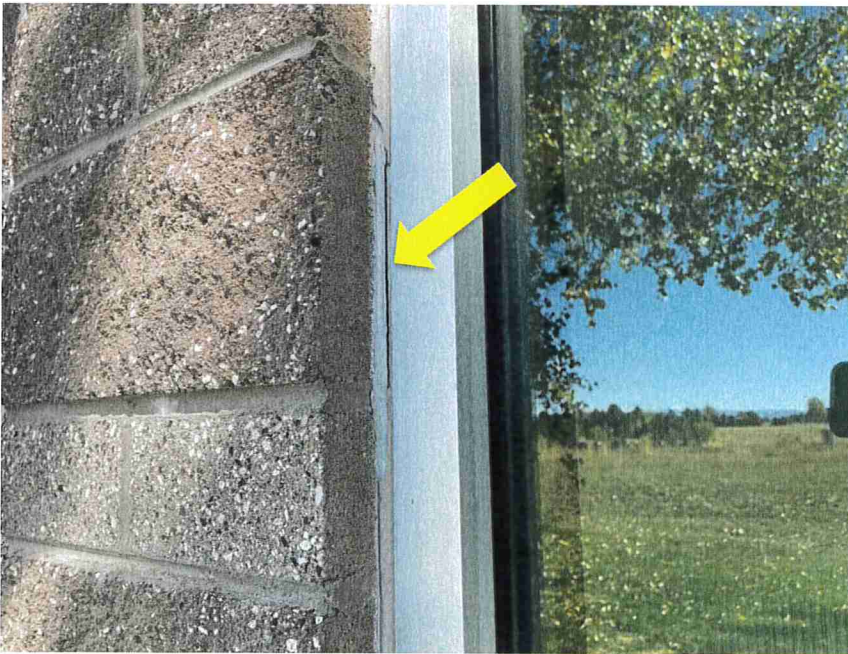
Photo 50 – Sealant was missing at a portion of the window jamb, but the remaining sealant did not have cracks or holes.

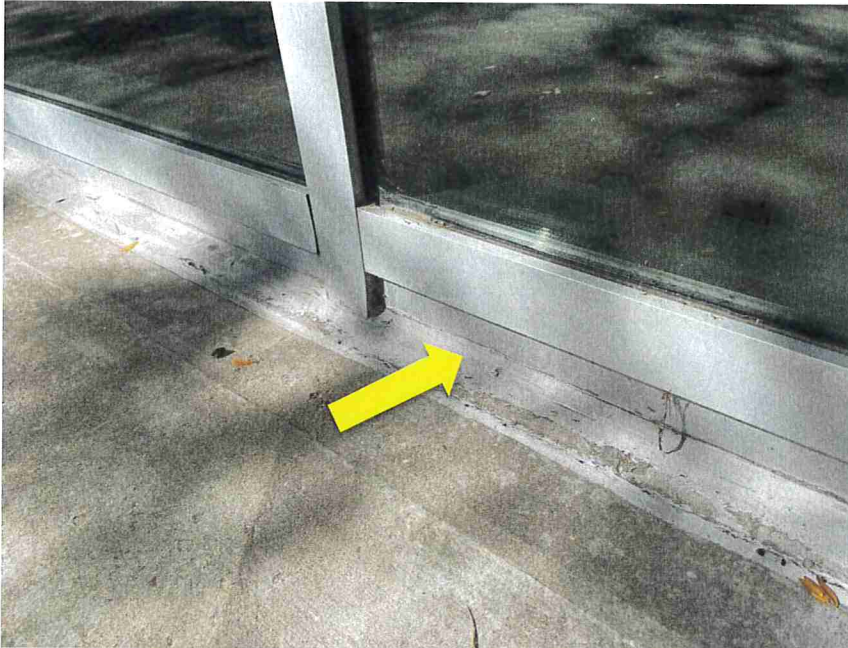
Photo 51 – Sealant joints were located below the storefront systems.

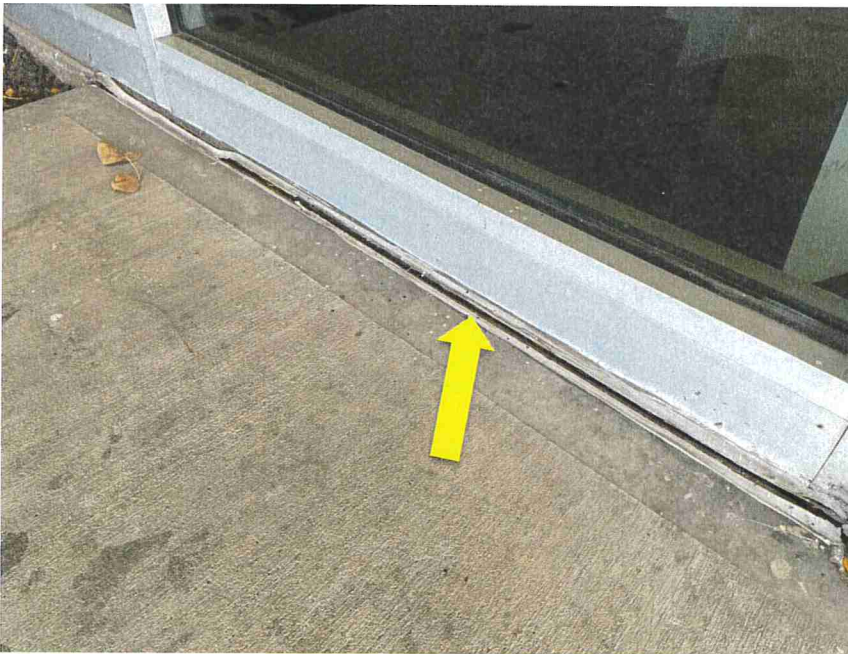
Photo 52 – Cracks and holes (indicated) in the sealant below the storefront system were observed around the building perimeter.

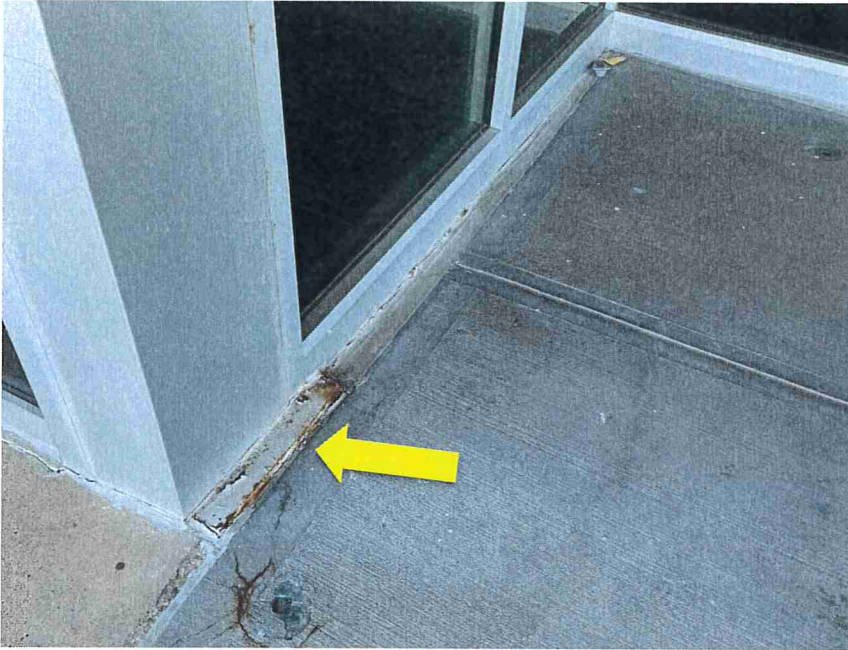
Photo 53 – A steel base plate was exposed and corroded (indicated) at the exterior of the storefront at the north entrance.

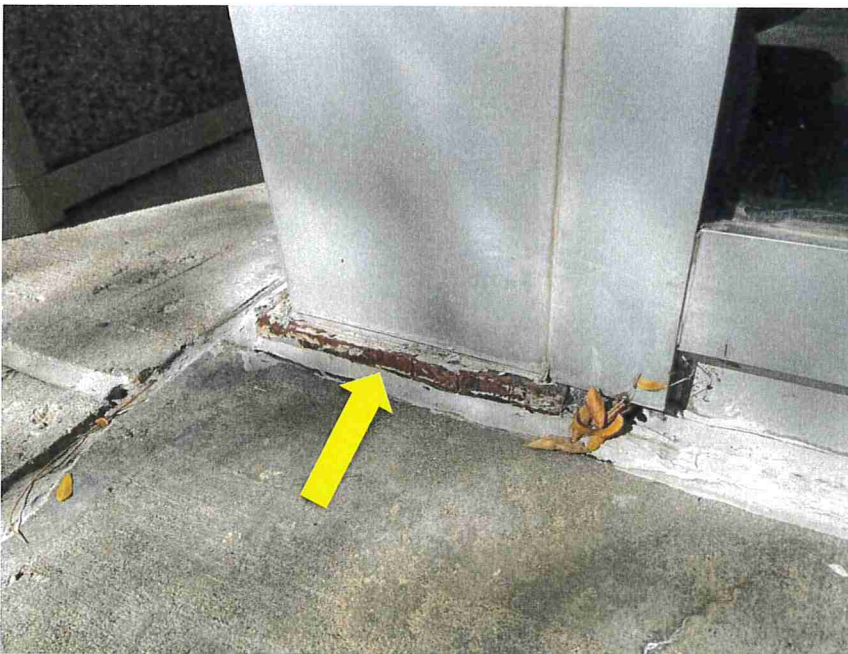
Photo 54 - A steel base plate was exposed and corroded (indicated) at the exterior of the storefront at the south main entrance.

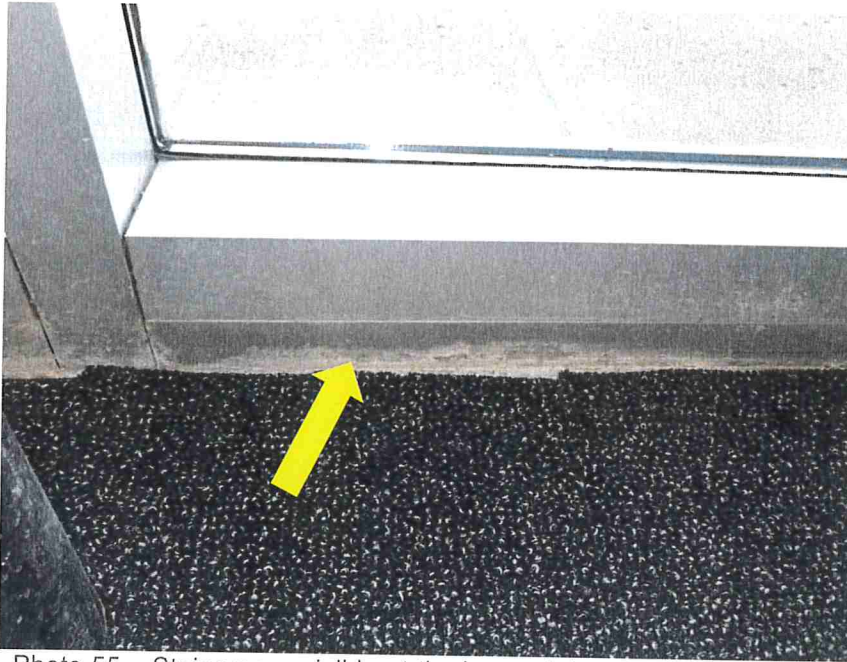
Photo 55 – Stains were visible at the base of the entrances, along the interior.

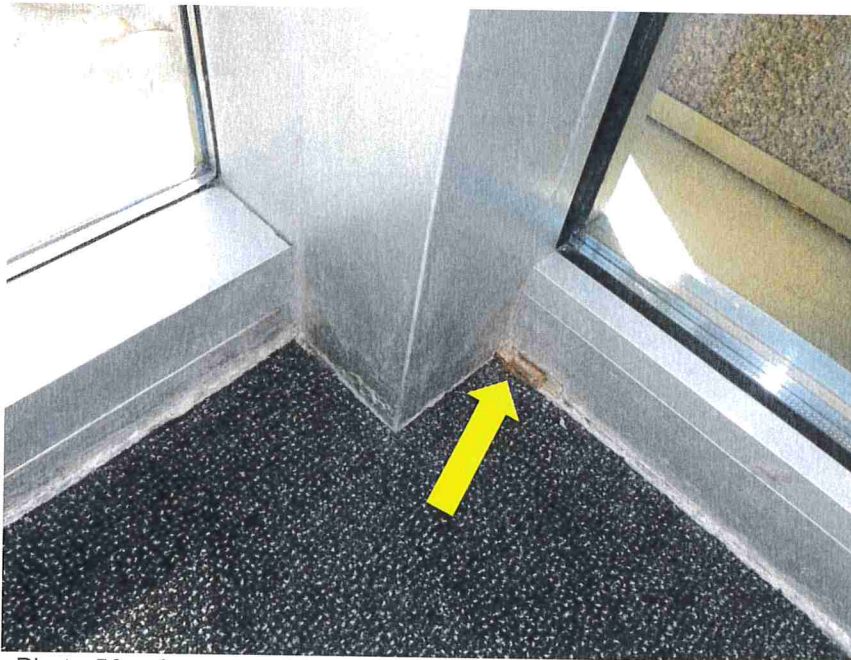
Photo 56 – A corner of the corroded base plate (indicated) was visible from the interior of the building.

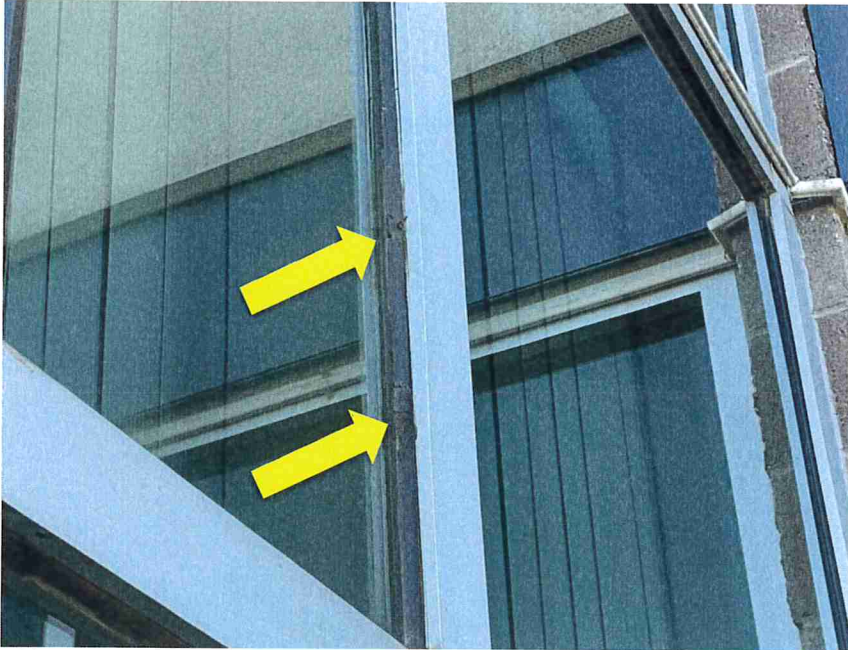
Photo 57 – Seals at the curtainwall on the north side had cracks and holes.

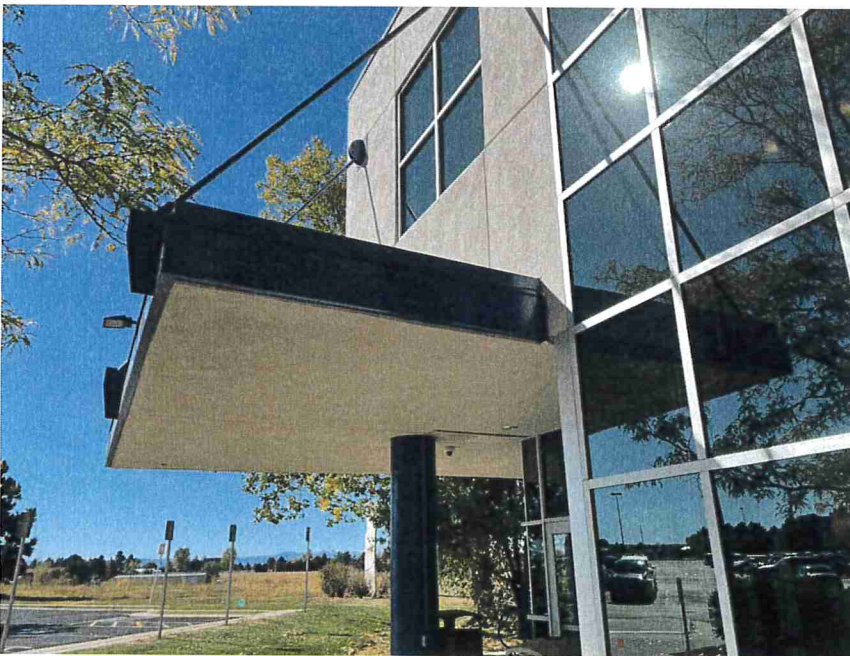
Photo 58 – View of the canopy soffit at the main entrance on the south side of the building.

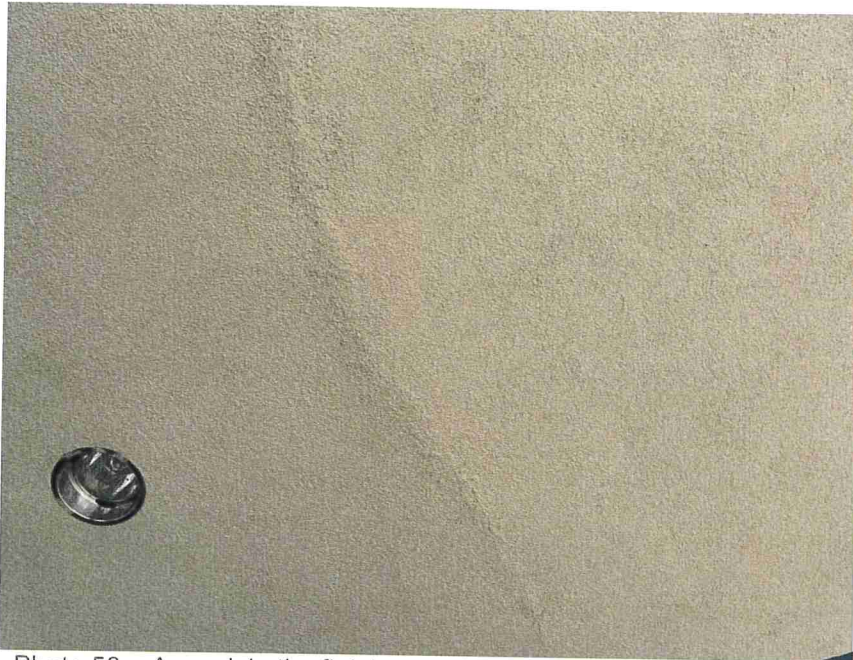
Photo 59 – A crack in the finish was observed at the underside of the south canopy. No stains were visible.

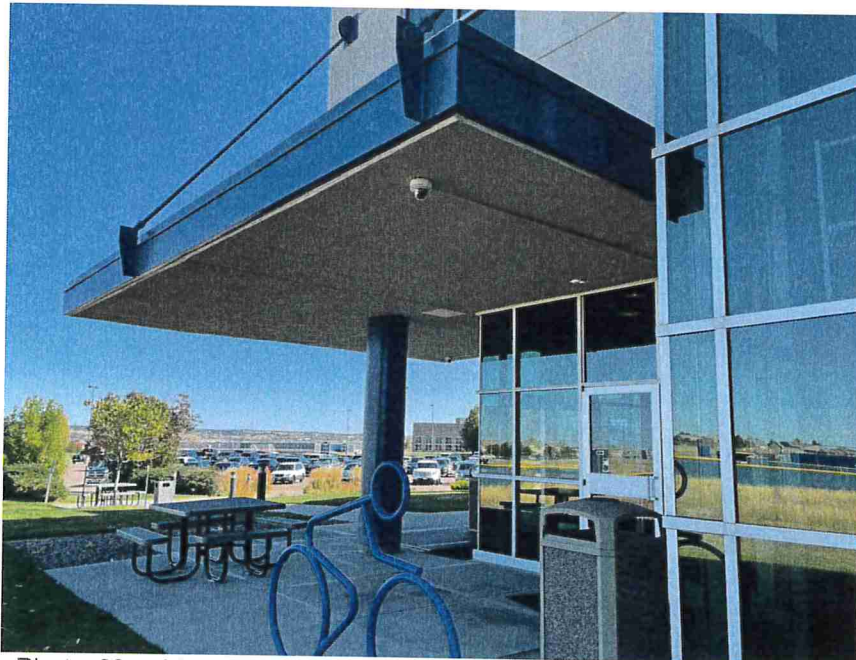
Photo 60 – View of the canopy soffit at the northeast corner of the building. No cracks or staining were observed at this location.

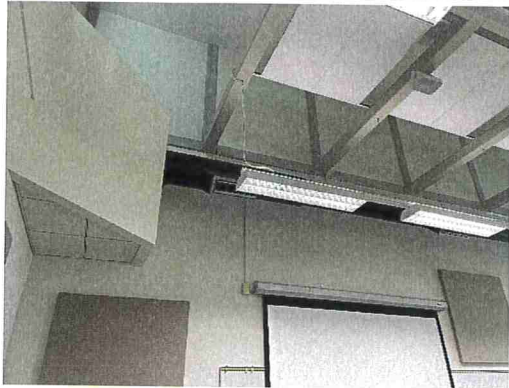
The majority of the ductwork within the building was installed during the original construction. Exposed duct appeared to be in good condition. Ductwork is also located in ceiling plenum space and assumed to be in similar condition.

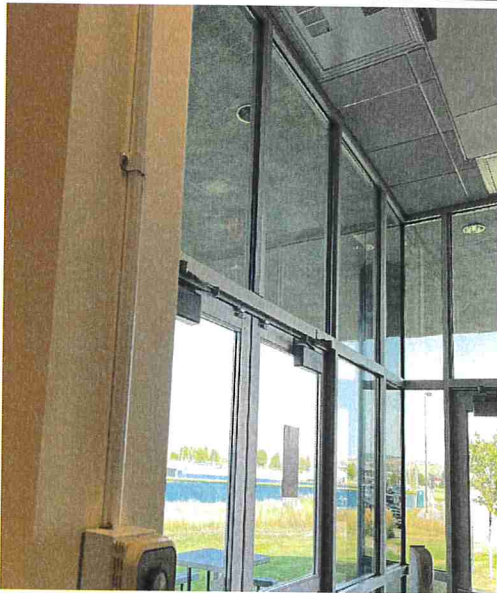
Cabinet Unit Heaters:  
Service Life Estimate (SLE) 20 years

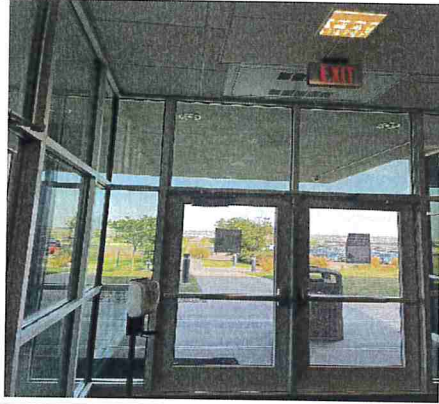
### 3.1.7 General Exhaust Fans

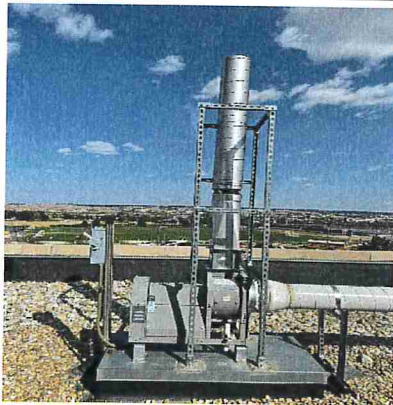
EF-05 (Fume Hood Exhaust)  
Greenheck CSW-X-10-CW-UB-0-A

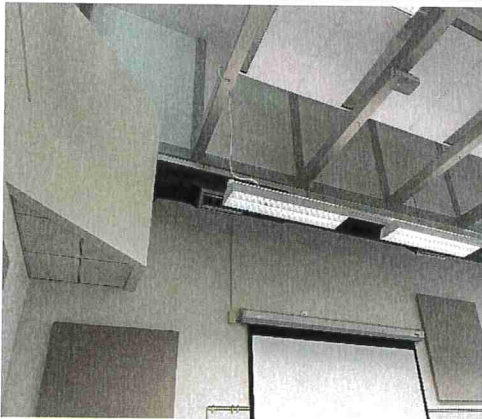
Air Terminals Service Life Estimate (SLE) 20 years.

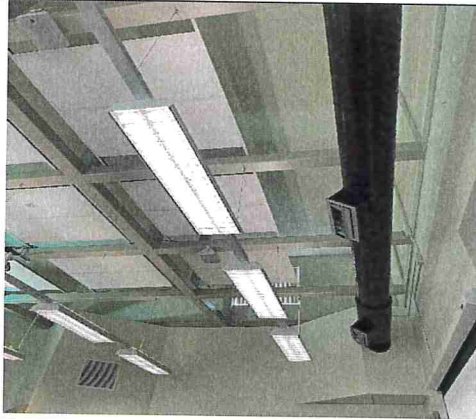
### 3.1.9 HVAC Controls

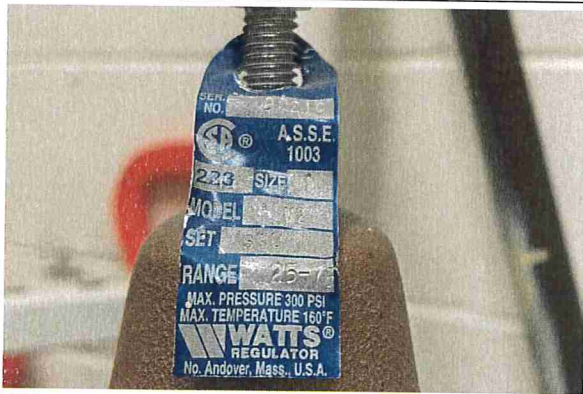
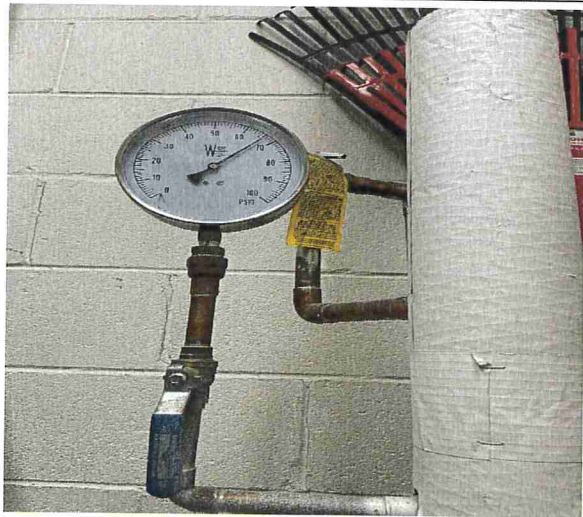
Domestic Cold-Water:  
The water entry is a 1-1/2" service.  
The incoming water pressure was at approximately 75 psi at the time of this site survey.  
The domestic cold-water system throughout was not accessible because it is above ceilings and within walls. The domestic cold water backflow preventer (BFP) needs to be tested annually. These reports should be located and reviewed to determine if there are any issues with the BFP.

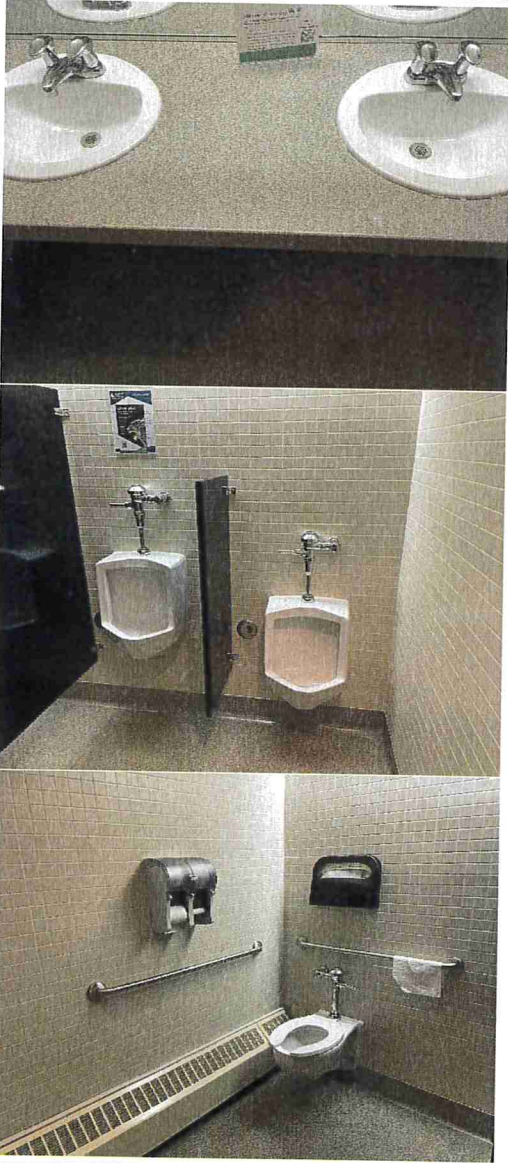
#### Plumbing Fixtures:

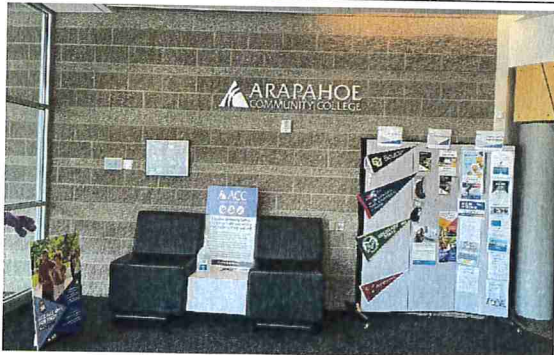
The building does not have a fire protection sprinkler system.
