# Douglas County Schools

Douglas County School District  
620 Wilcox Street  
Castle Rock, CO 80104

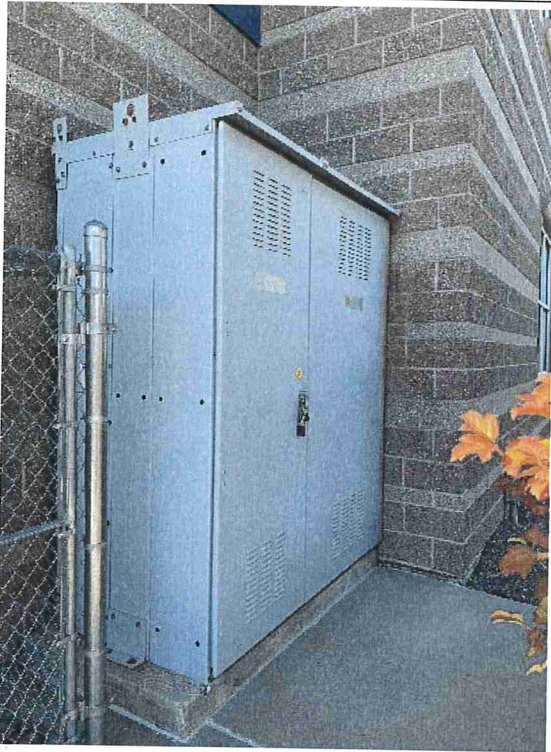
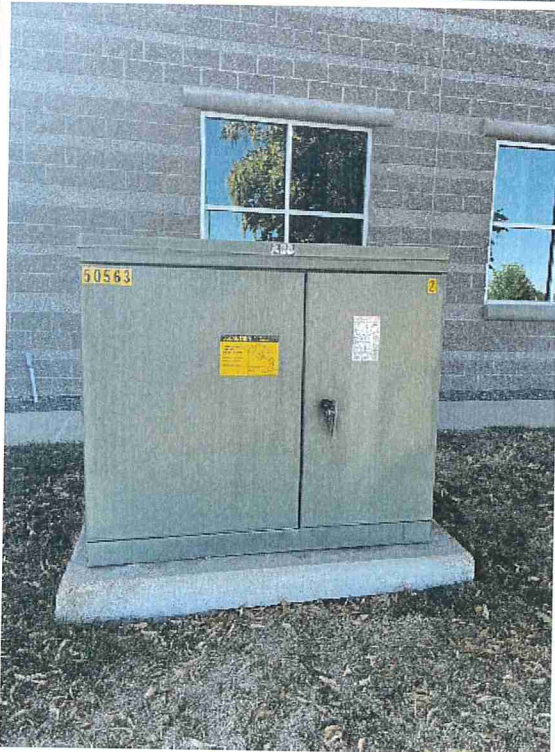
The building's electrical service is provided by CORE Electric Utility Company (Formally IREA). The existing electrical service consists of a utility owned pad mounted transformer (rating of transformer is unknow), that provides 480/277V, 3-Phase, 4-Wire service to the building. It is assumed that transformer is adequately sized for any new renovations. The transformer, EUSERC Cabinet and utility meter appear to be in good condition and do not require immediate replacement. The incoming feeder from the transformer to the main switchboard 'MSB' are to remain as is.

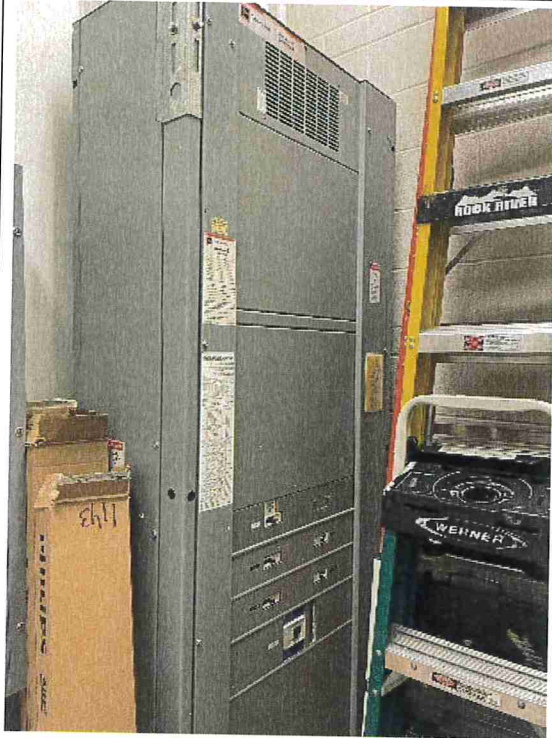
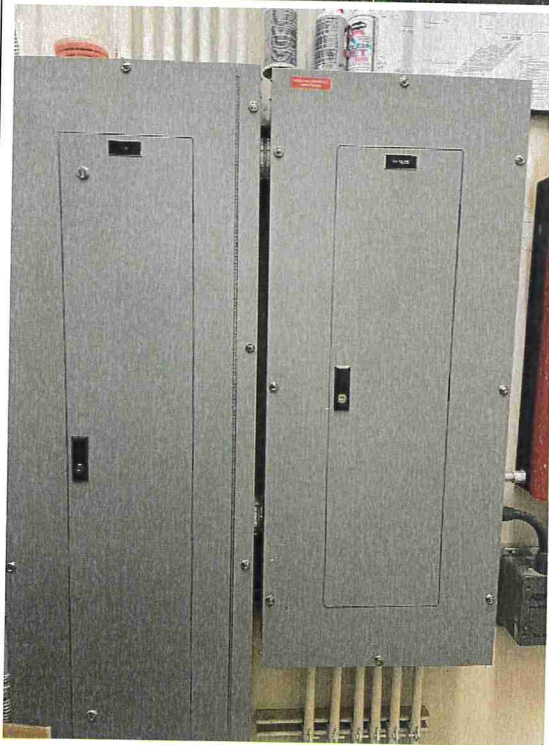
The building's main electrical distribution is 480/277V, 3-Phase, 4-Wire solidly grounded. The main distribution switchboard 'MSB' is rated 600A, 480/277V, 3-Phase, 4-Wire.

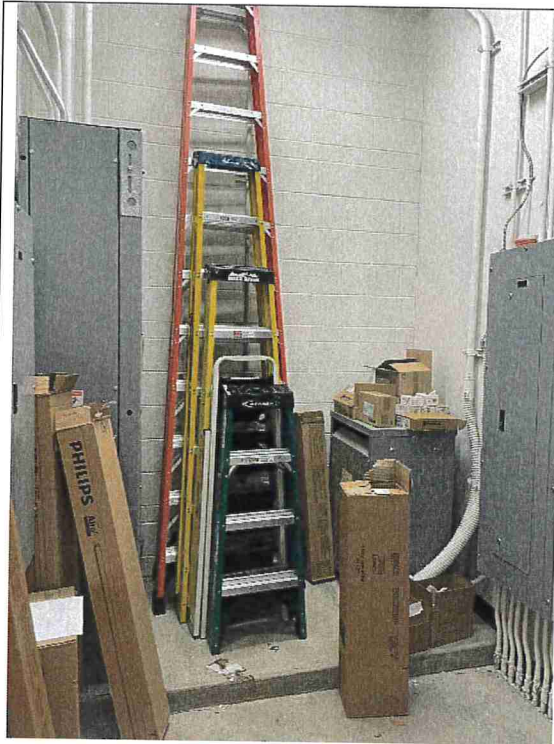
Most panelboards appeared to have spare breakers or space. The panel directories and labels on distribution board and sub-distribution board appear to be up to date.

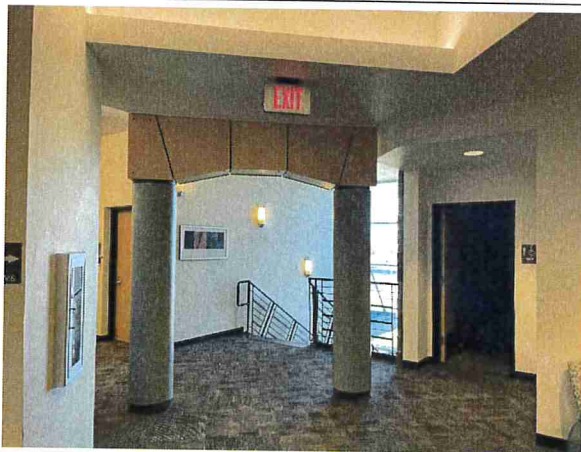
The building does not have an emergency generator and egress lighting/exit signs are served with local emergency batteries. An assessment of all egress lighting is recommended to verify all local batteries are functional and replace any that have served their life-expectancy.

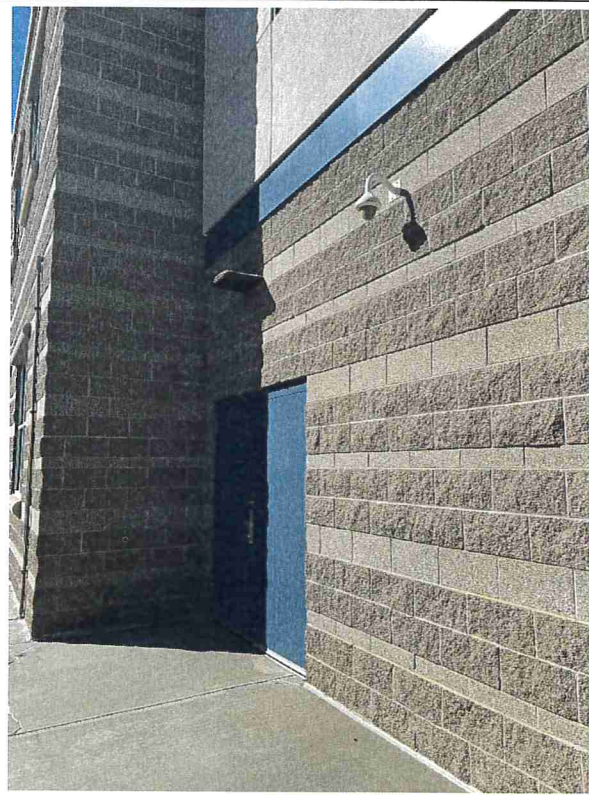
Exterior lighting consists of recessed downlights and wall mounted lights around the building. Majority of these fixtures contain fluorescent and HID bulbs.

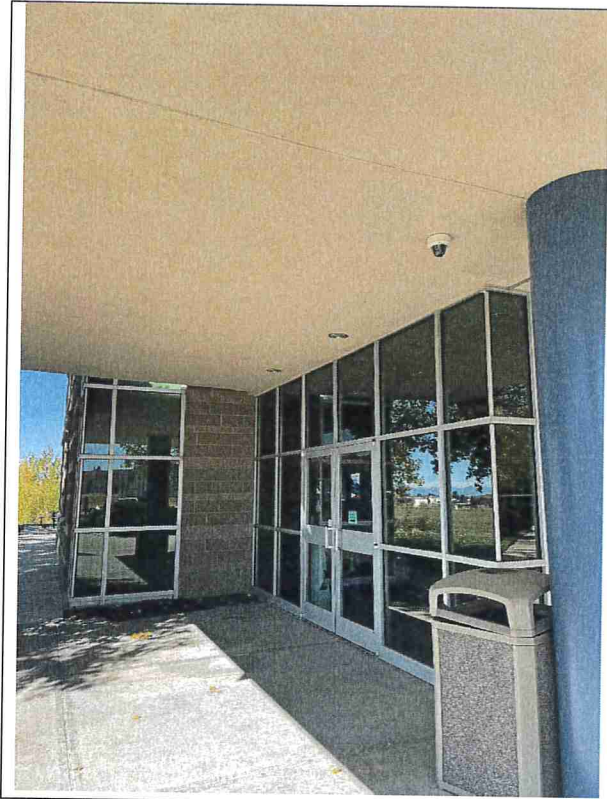
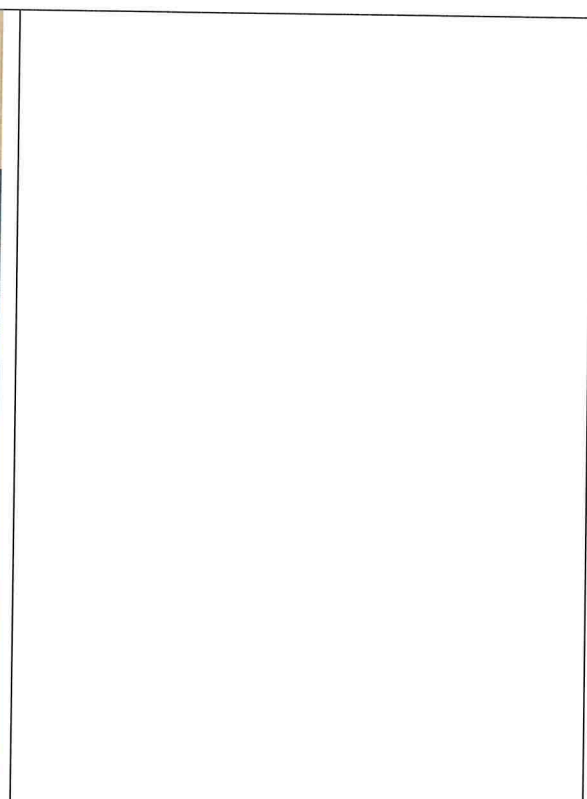
New LED lighting is recommended to be provided to conform with IESNA Guidelines for Security Lighting for People, Property, and Public Spaces. Exterior lighting control will be accomplished through the networked lighting control system, utilizing photocell and astronomical time clock control.

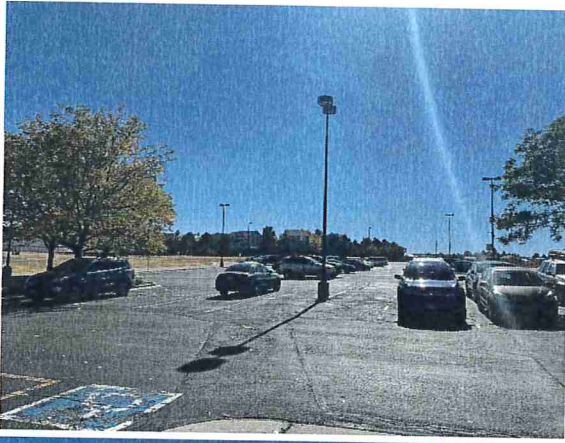
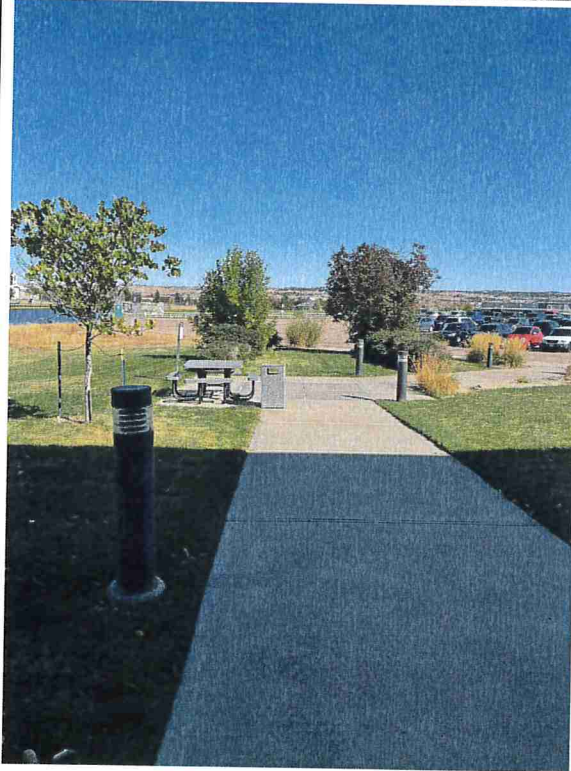
The exterior site lighting appears to be in good condition. The fixtures appear to be HID fixtures.

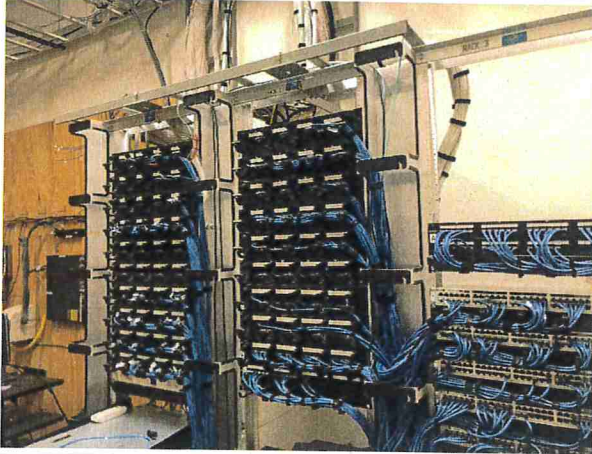
The current Arapahoe Community College – Parker Campus contains technology infrastructure for data, security and audio-visual systems. Many of these systems are believed to have been included with the original construction and are beginning to show signs of age. Functional testing would be required for any systems intended for reuse to verify current conditions.

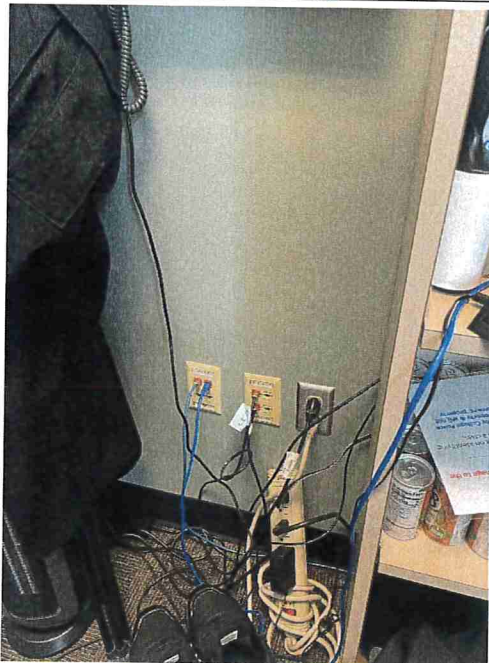
The horizontal cabling in the building included data outlets at walls in offices and classrooms, as well as connections to ancillary devices. Most classrooms contained 4-6 floorboxes with power and data as well as data at the instructor station. All horizontal cabling and data outlets observed in the facility was noted as Category 5 cabling. No fiber backbone was observed outside of the MDF.
